AVIATION INVESTIGATION REPORT

A03P0244

RISK OF COLLISION

NAV CANADA

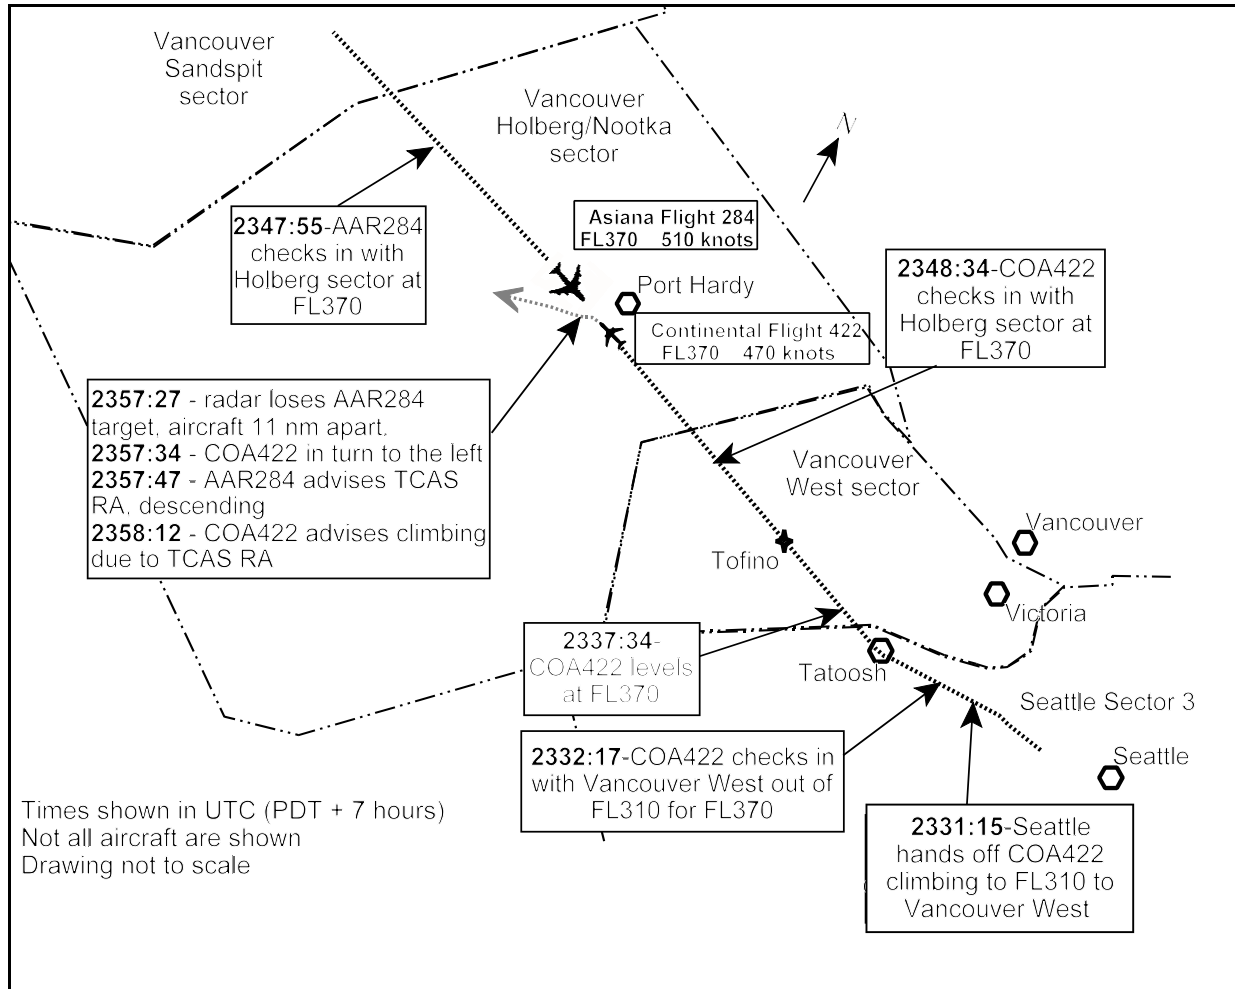
Appendix A – Sequence of Events

At 1632:17 Pacific daylight time,¹ COA422 contacted the West controller and reported passing FL310 for FL370 (see Appendix A). The West controller acknowledged with the word "roger" and, in the same transmission, asked the pilot to change the transponder code. No annotation to indicate reported FL was entered on the flight data strip. The West controller did not observe the change in FL as COA422 continued the climb above FL310 and did not notice that COA422 was at FL370 for the 10 minutes prior to the handover to the Holberg/Nootka sector.
